# 2015 Facilities Master Plan

## Butte-Glenn Community College District

## **Buildings**

### **Condition**

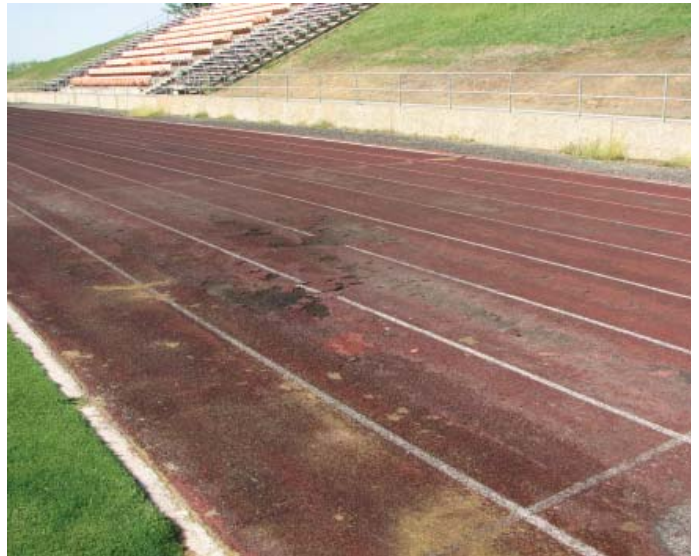
- The turf grass playing fields and practice fields are in good condition due to a recent field enhancement program.
- The tennis courts are unusable due to the condition of the playing surface.
- The track and field facilities are in poor condition. The running track is still being used for general exercise, although it is in poor condition.
- The softball field recently received new dugouts and is slated to receive some additional work to the backstop.

Running track

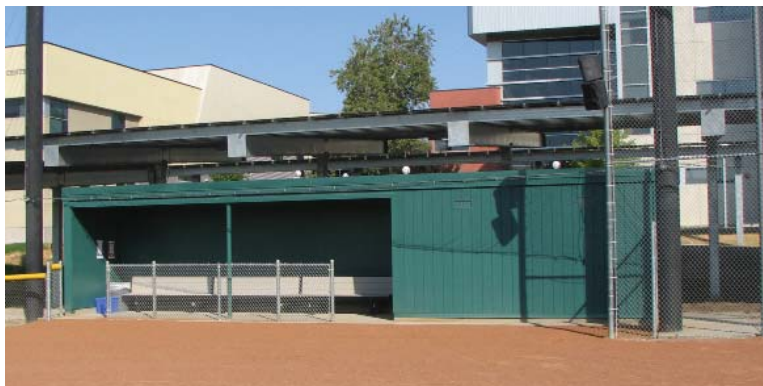
New softball dugout

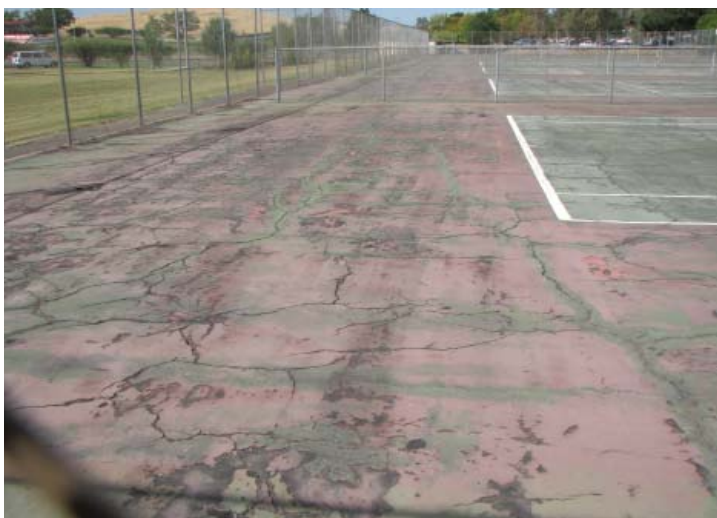
Tennis courts

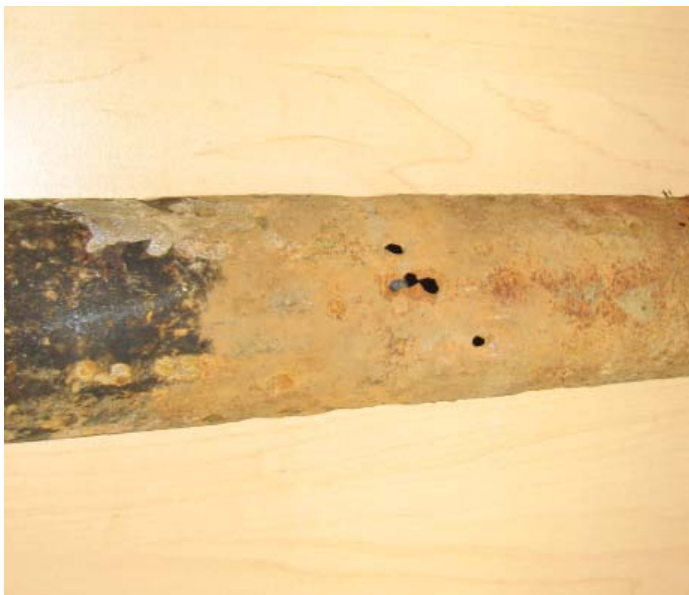
The natural gas distribution system was installed when the campus was originally built in the early 1970s. It is primarily constructed of PVC piping, with some unprotected black iron pipe mixed in. The PVC portions are still in serviceable condition but present potential hazards in the event of an earthquake or an accidental disruption from digging activities. This type of piping would no longer be allowed by the building code. The black iron pipes have rusted over the years and occasionally begin leaking, creating both a cost and a potential danger.

Section of gas pipe recently replaced

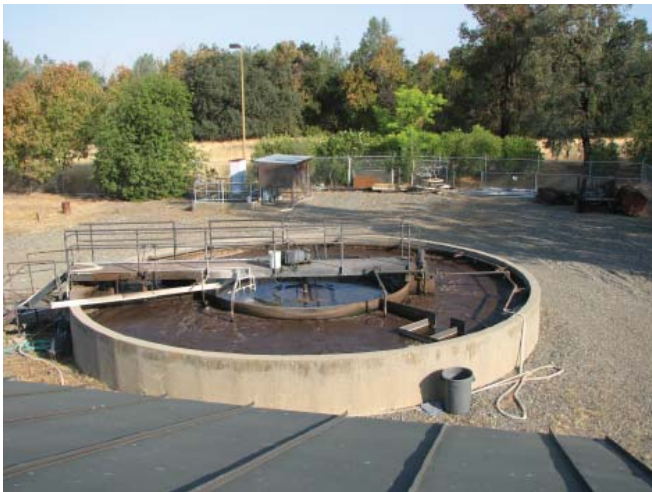
Sewer treatment plant

The sewer piping infrastructure also was installed during the original construction of the campus and is showing signs of deterioration. There is currently not a need for wholesale replacement of this system. Sections are addressed as they fail, causing short-term use interruptions.

The major components of the sanitary sewer system are the collection piping and the treatment plant. The treatment plant relies heavily on a series of pumps and aerators. One of the large air pumps was replaced in 2013, and several other pieces of equipment are scheduled for replacement in 2015 with Scheduled Maintenance funding. This should allow the treatment plant to function adequately for several years.

The collection piping is original to the campus and occasionally fails, usually due to root invasion. In 2014 a major cleaning of the system was performed. That should keep the system operating adequately for a few years. However, because of the age of the system, it will continue to fail occasionally, and funding needs to be available to respond to these instances.

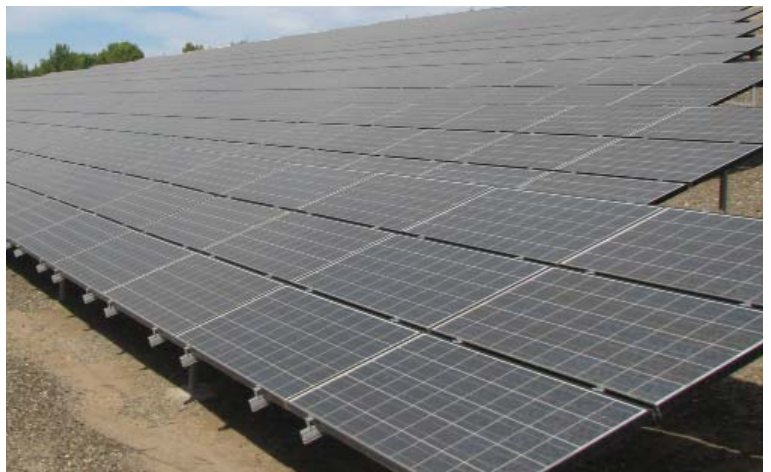
All of the PV arrays and supporting equipment are the property and responsibility of the District. The first phase of PV installed in 2005 is showing deterioration of the inverter and transformer equipment. Replacement of this equipment will need to happen in the next few years. Subsequent phases also will need maintenance in the coming years as they reach the life expectancy of the equipment.

Solar panel array

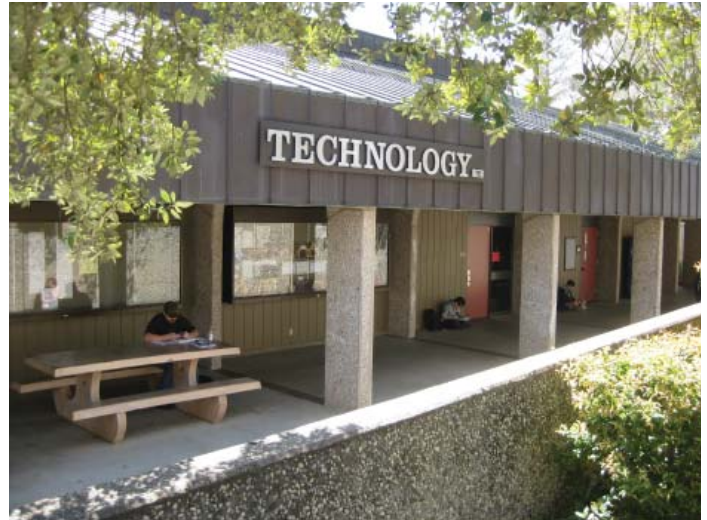
The Technology building is one of the original buildings from the move to the current location. It was built in 1974 for use in teaching the technology of the day. Over the intervening years, the building has been reconfigured several times as the instructional needs changed. It is currently used to house the Mathematics program. It is not particularly well configured for that use, and many of its systems are reaching the end of their useful lives. The project to gut and remodel this building was developed several years ago and has been submitted to the California Community College Chancellor's Office for state funding.

Technology building

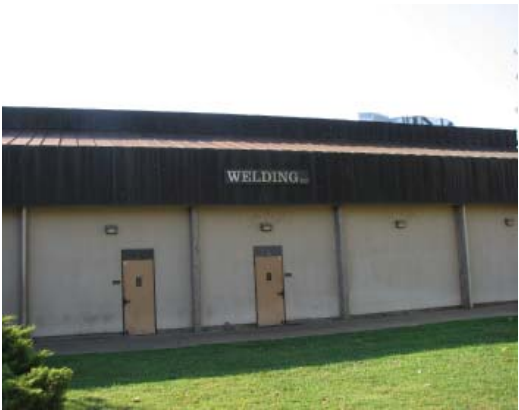
Welding building

The current Welding building is also one of the original buildings on the main campus. It has one of the highest facility condition indexes (FCI) on campus at over .70. Typically, when a building has an FCI in excess of .50, it is more cost effective to replace the building than it is to repair it.

A study of the possibilities for renovating, expanding, or relocating this program was accomplished in 2014. The recommendations of that study are that it will best serve the District and the students to construct a new facility at a different location on the main campus. It is recommended that this new facility be approximately double the size of the current facility to allow for an increase in the student population of this program. This project would include appropriate landscape screening.

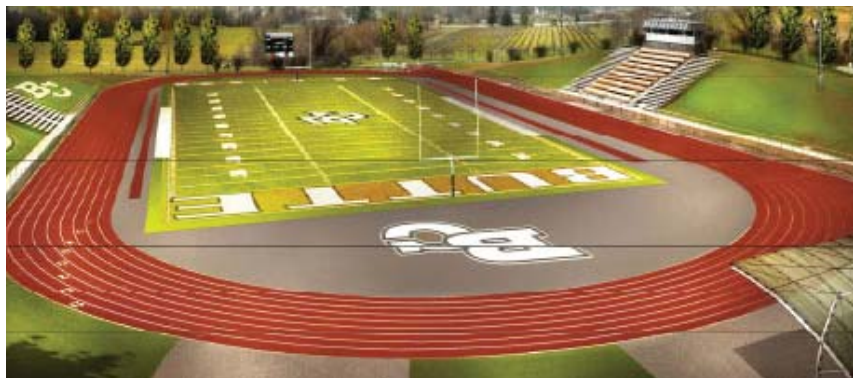
Below is an artist's rendering of the football field and running track from the master plan.

- Football field renovation
- Track replacement
- Football press box replacement
- Field house replacement
- Lighting for football, baseball, softball, and soccer fields
- Soccer stadium
- Practice field upgrades
- Tennis court renovation and/or removal
- Gymnasium upgrades
- Locker room upgrades

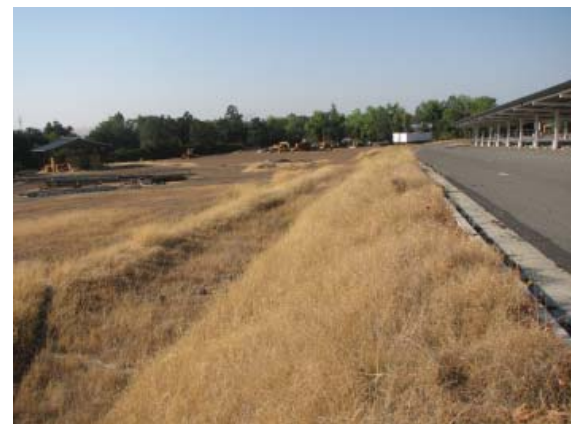
The Agriculture Yard project will reconfigure the currently unusable area on the east side of campus for use by the Mechanized Agriculture classes. It will also complete phase II of the Bio-filtration Wetland Environmental Learning Laboratory (BWELL) project, which was started in 2011. Phase I installed the upper portion of the bio-swale along the east side of Parking Lot 4. This project will install the lower portion of that bio-swale and complete the filtration of the storm water that runs off the parking and drive areas. This project has received the needed permits but has not been funded.

BWELL Bio-swale

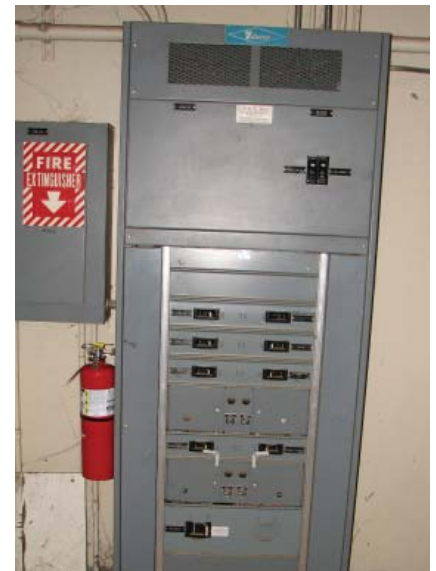
Original electrical panel

The high voltage distribution and primary transformers are the property of PG&E and are maintained by them. All of the switchgear, panels, and lower voltage transformers are the responsibility of the District, and most are reaching the end of their useful lives. If the State continues to provide Scheduled Maintenance funding in coming years, this equipment can be systematically replaced. If that funding stream does not continue, there will be a critical need to replace this equipment with other funds.

For all the utility infrastructure components, it is recommended that a repair and replacement fund be established to provide the needed maintenance. These systems eliminate the need to pay monthly utility bills, but they only sporadically receive funds for repair or replacement. Systematic attention to maintenance can be more cost-effective than responding to emergencies when components fail.

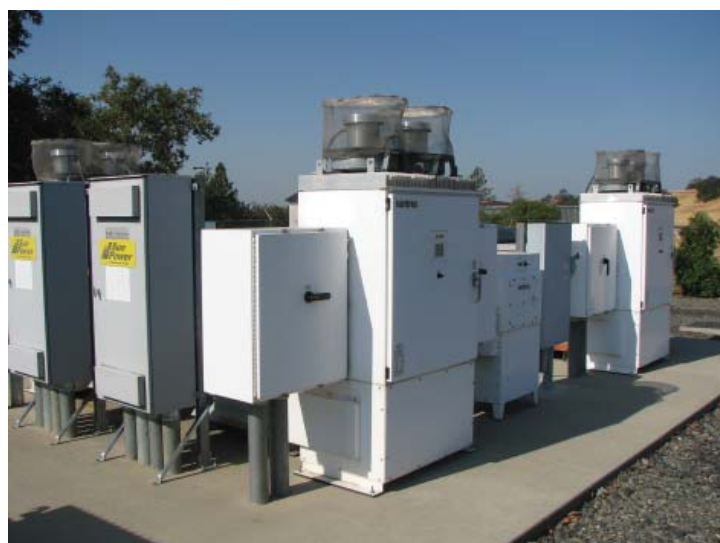
Phase I solar inverters

showing signs of deterioration. The first system, installed in 2005, at times has not produced energy because of component failure, primarily the inverters and transformers. These devices suffer from the high heat levels that are produced by their functions and by the ambient temperatures of our campus. It is critical to keep these systems functional because of the high cost of energy when purchased.

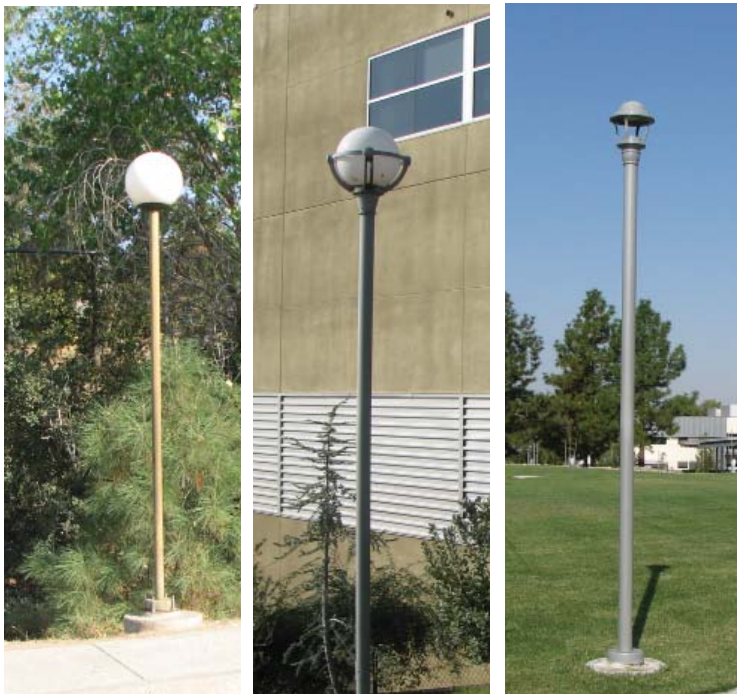
Three styles of walkway lighting on the main campus

Another aspect of pedestrian circulation is adequate lighting for use during the night hours. Many of the existing walkway lighting fixtures are original to the construction of the campus. They are reaching the end of their useful lives and need to be replaced.

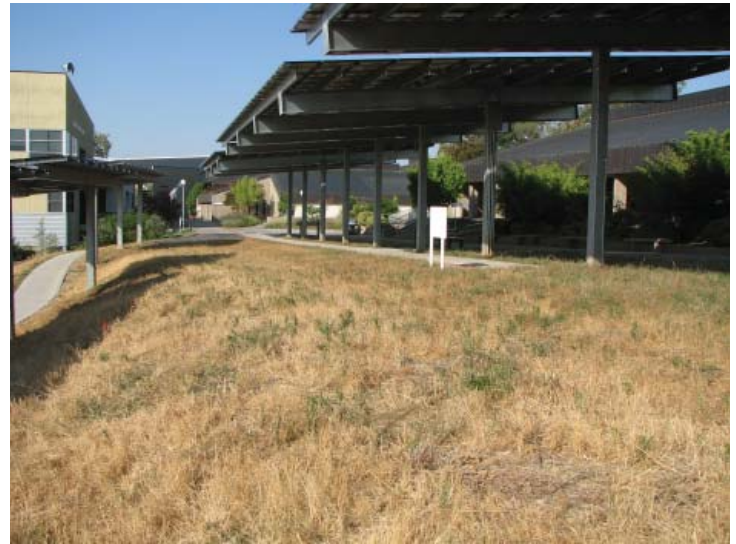
Several areas of turf grass have been proposed for replacement with native grasses that are low water users. Already in progress is the area south of the Physical Science building. Other areas will be transformed as funding allows.

Native grass at the Physical Science lawn
